Strathmore Walkability Assessment

1. Introduction

1.1 20-Minute Neighbourhood Pilot Program

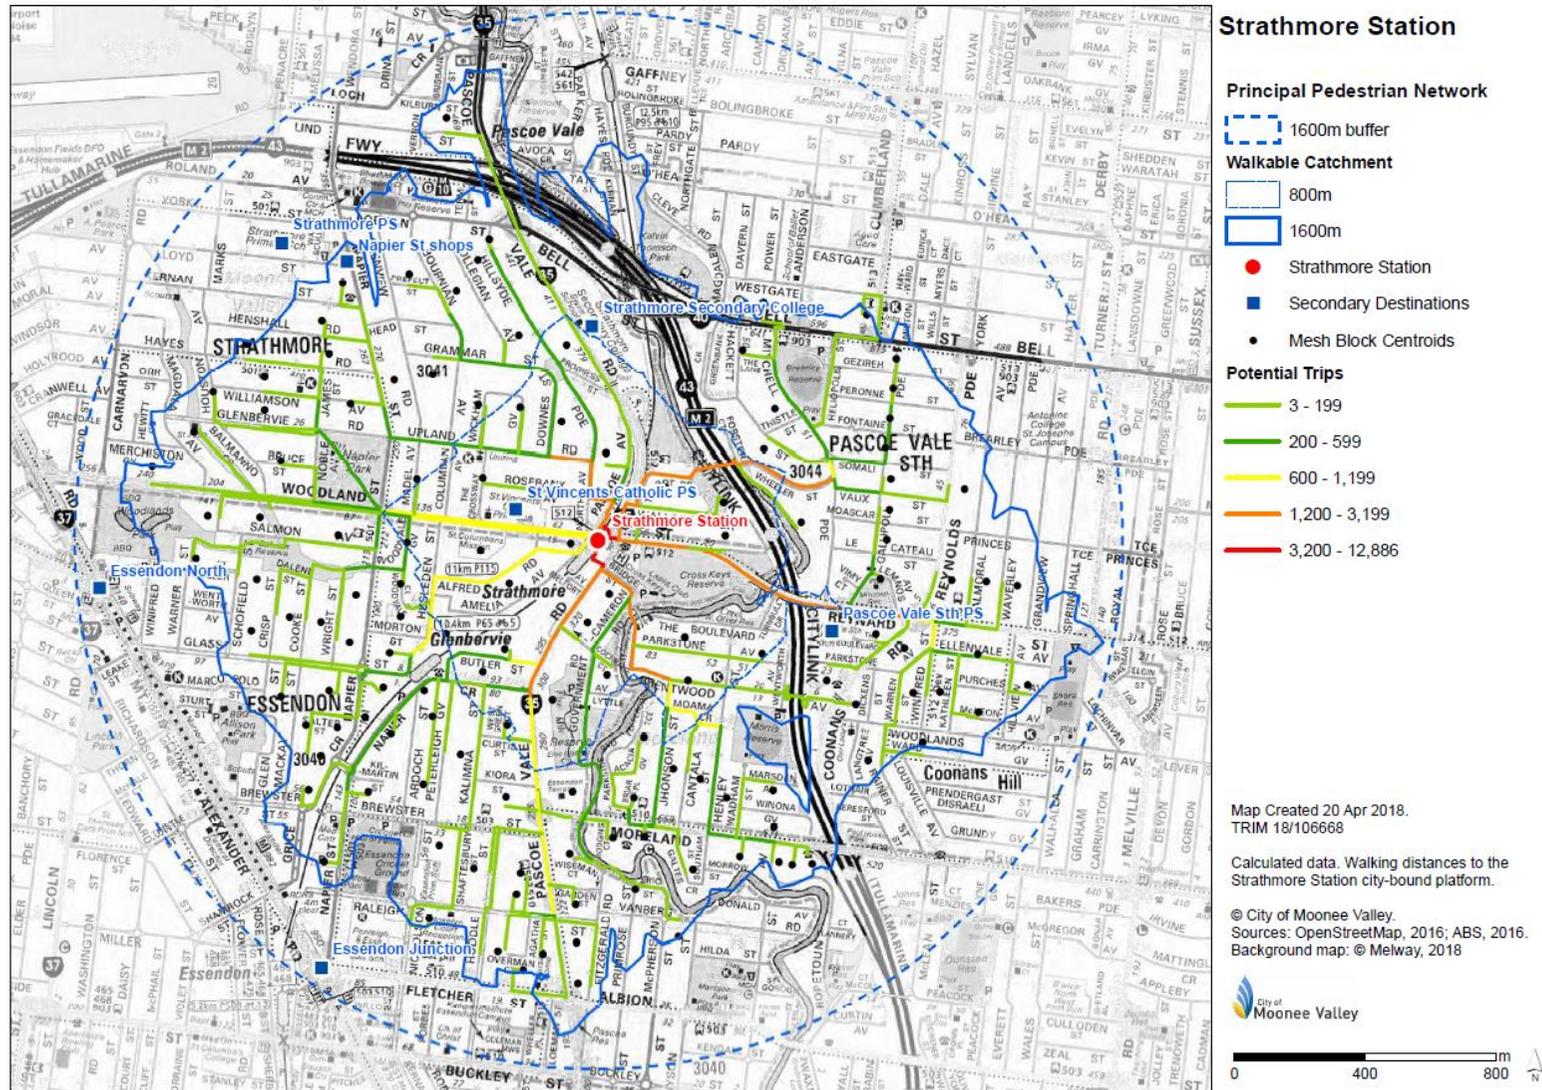
Figure 1. Estimated demand for walking routes to Strathmore centre

- All of the routes with potential for more than 600 trips (yellow, orange and red on the demand map in **Figure 1**).
- Some streets within the core 800m catchment that were predicted to support between 200 and 600 potential trips – Upland Rd, Downes St, Hillside Parade and Cameron Rd.
- Streets immediately surrounding the secondary destinations of St Vincents Primary School and Glenbervie Station.

PPN Demand Map

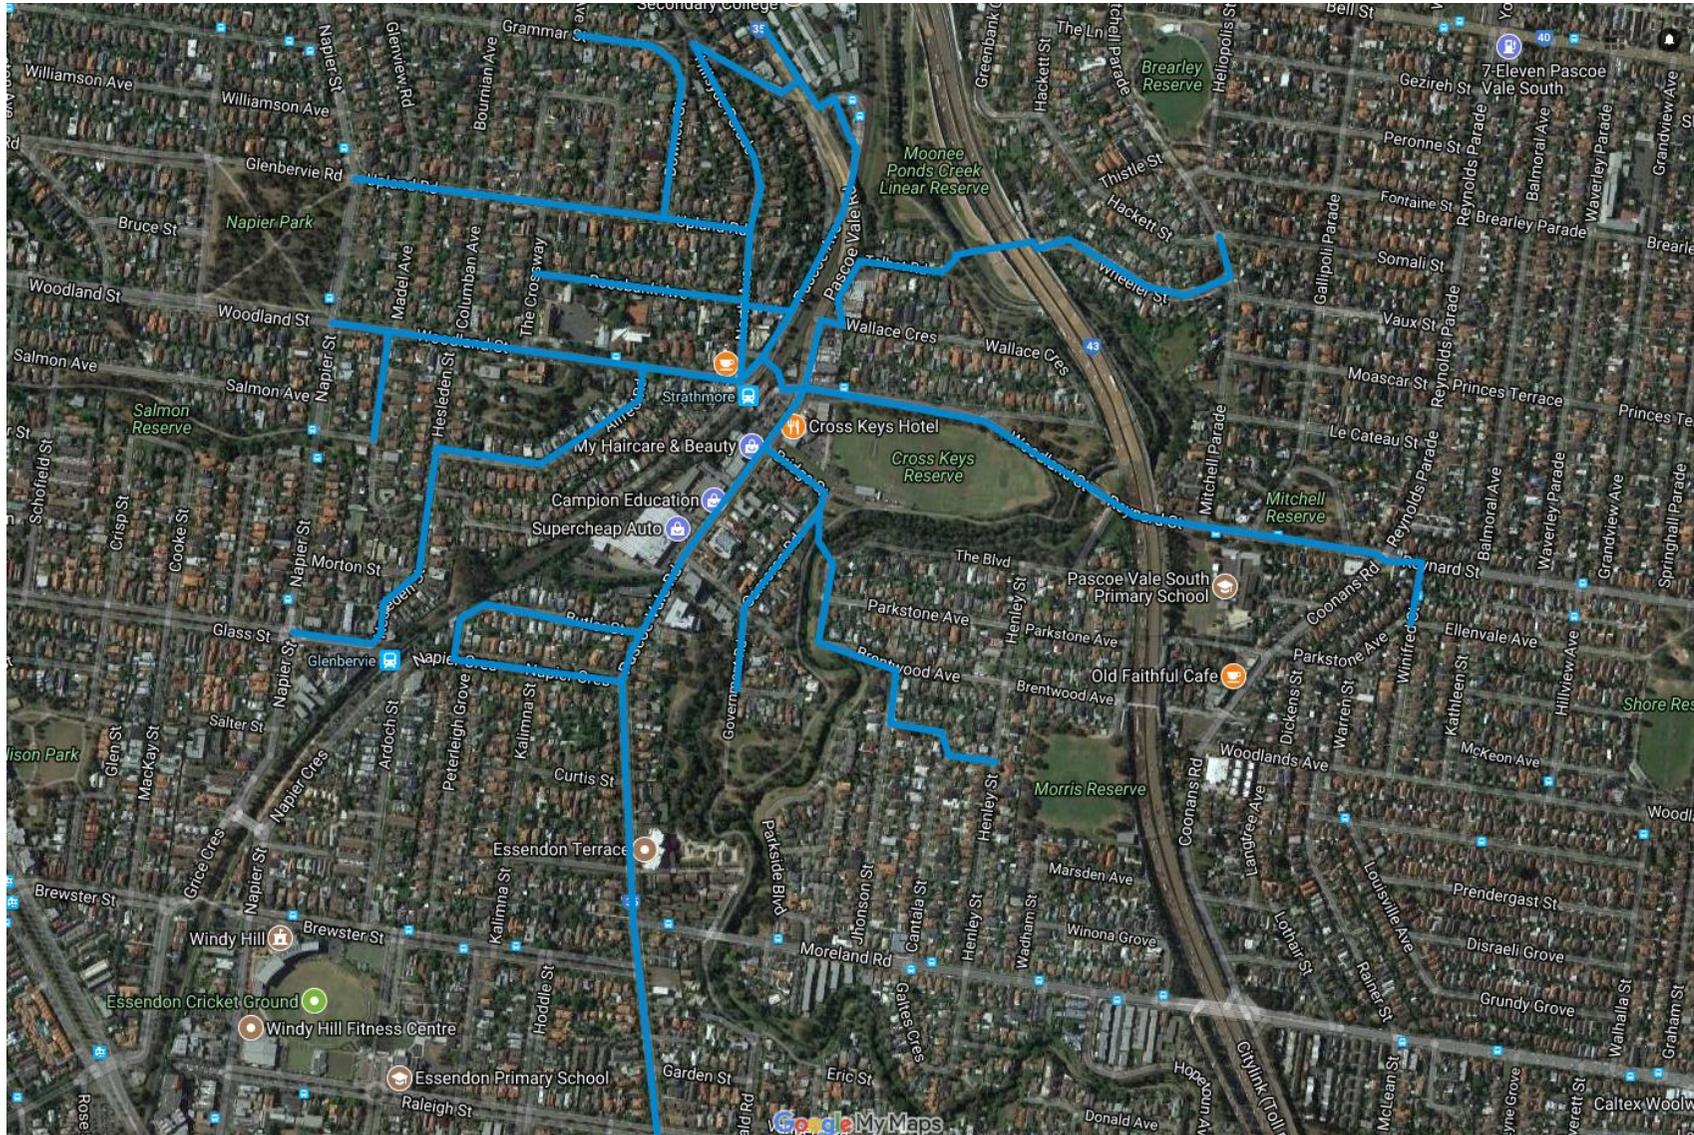
Figure 2. Key routes identified for assessment (prior to on-site evaluation)

A map of routes identified for assessment can be seen in **Figure 2**. It is notable that while the walkable catchment for Strathmore sits largely in Moonee Valley, much of the catchment extends into Moreland.

Routes identified for Assessment

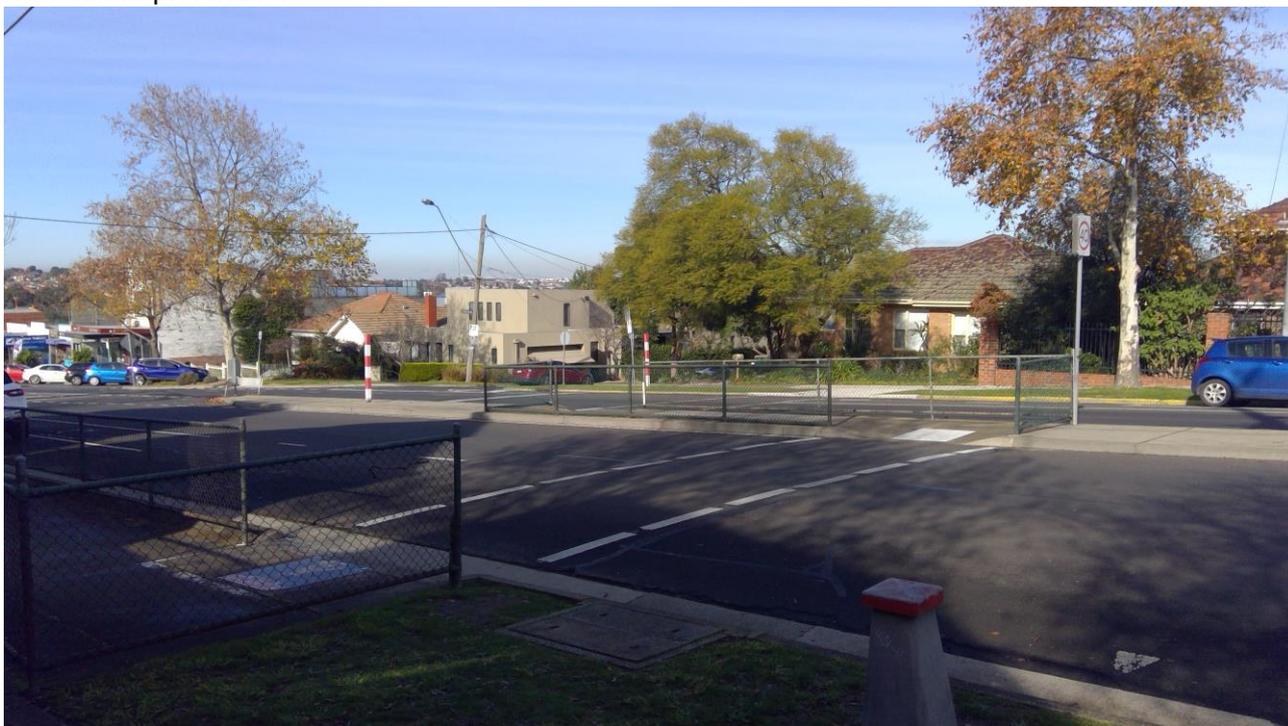
There is a need for a pedestrian crossing of Woodland St at the western end of the shops, to ensure that people walking to the centre from the west are able to conveniently and safely access shops on the opposite side of the road. This is particularly important for vulnerable pedestrians – children, older

This crossing would ideally be provided on the eastern side of Alfred Rd to cater to people using that street. However, given the existing school crossing and the need to provide access to the school, it is perhaps more logical to adapt that crossing to serve both purposes. The current MVCC plan is to provide raised platforms for the existing crossing. This should become a raised zebra to meet the needs of all users, at all times. From a pedestrian perspective the existing configuration of a two-leg, staged crossing is highly undesirable as (depending on the direction they are walking) it may require people to double-back on themselves. This would stop many people from using it and a direct crossing is therefore preferable.

Figure 3 Existing school crossing of Woodland Street, at Saint Vincent de Paul PS

1. Adapt existing plans to replace the existing school crossing with a raised zebra crossing extending directly across Woodland St (priority high).

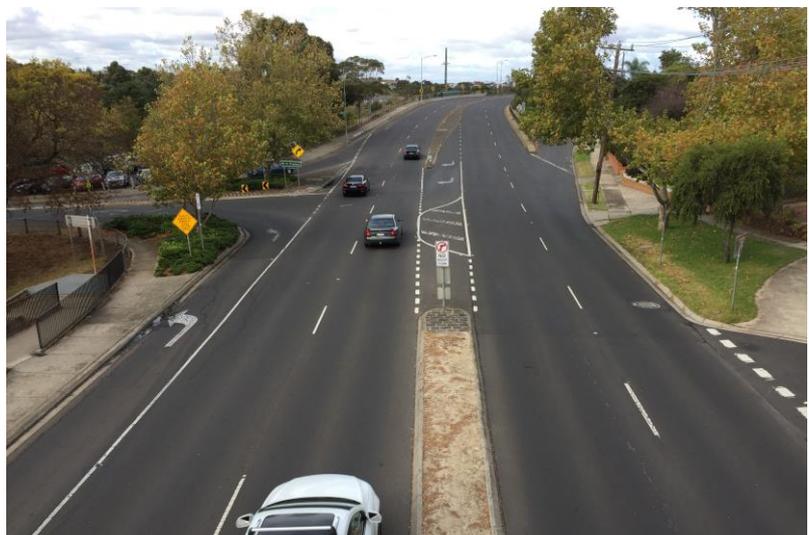
The assessment raises a number of concerns around access to the Secondary College. There is an existing overpass across Pascoe Vale Rd but discussion with a small number of students suggest many do not use it because it is quicker to cross the road at grade. A 40km/h limit applies during school times (otherwise 60km/h) but the design of the road does not reflect this at all, in fact the railway overpass gives it an expressway character.

Figure 4. Pascoe Vale Rd from ped overpass at Strathmore SC, illustrating left turn into Pascoe Ave

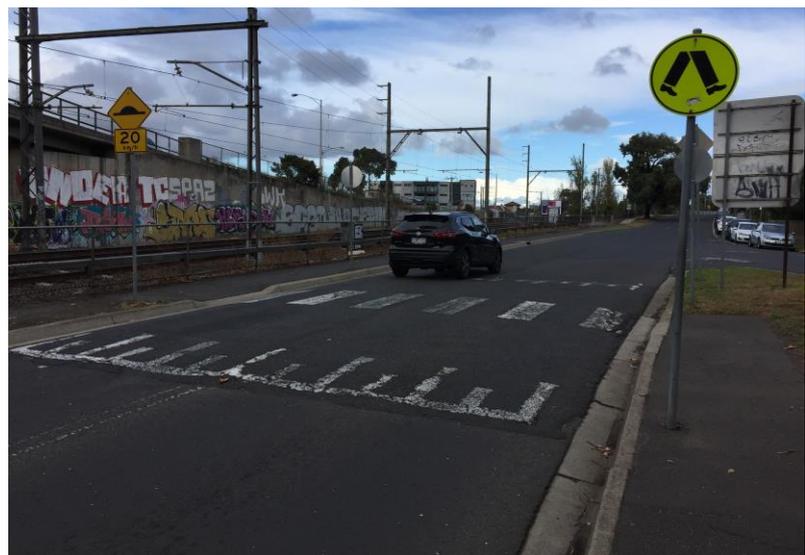
Figure 5. Pascoe Ave (existing crossing)

Point 68. Poorly maintained crossing	Pascoe Ave	The raised crossing at this point is an important connection between the Station and Secondary College and is well located, as the footpath on the eastern side of Pascoe Ave does not extend north of this point, so students are required to cross here. However, the platform is not high enough to generate significant vertical deflection and the line marking is in poor condition.	Reconstruct crossing with a higher platform and new line marking	H

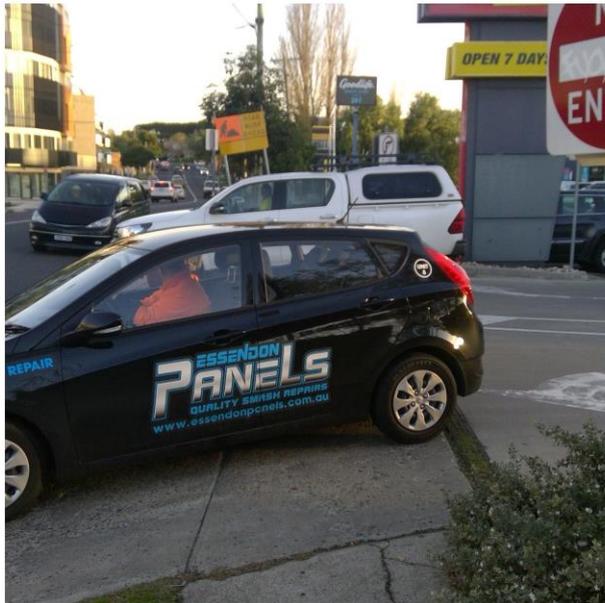
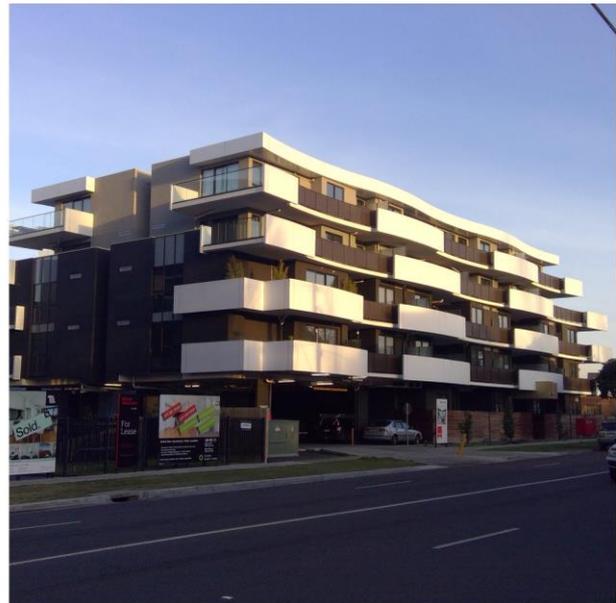
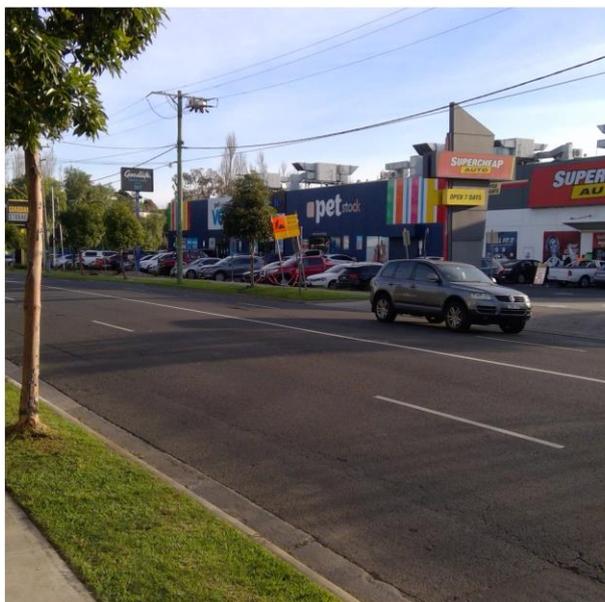
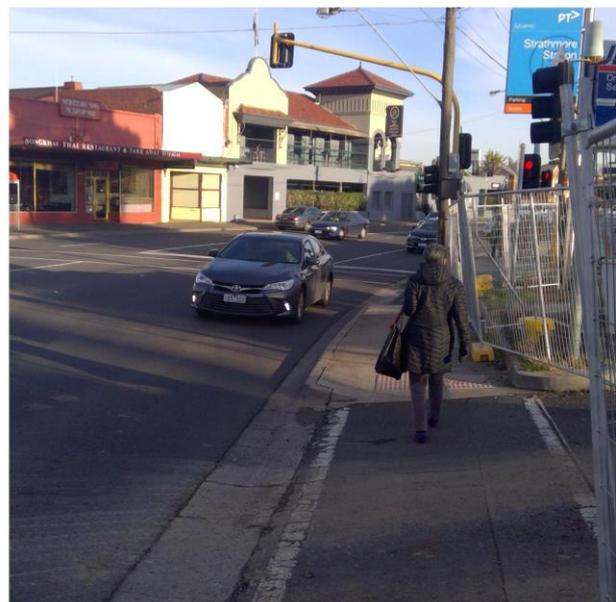
The centre on Pascoe Vale Rd presents a significant challenge and illustrates tensions between current planning and transport objectives. The large apartment buildings that have recently been developed reflect Strathmore as a destination itself and with excellent access to other destinations via public transport. In practice, however, Pascoe Vale Rd is currently managed for its traffic movement function, not to get people to the centre but to get them through it as fast as possible.

Despite the fact that it is not very pedestrian friendly, we observed a range of people walking along Pascoe Vale Rd in the centre and further south, tending to confirm the PPN analysis suggesting it is a key pedestrian route to the centre. This included school children as young as about 10 years old, walking independently.

Figure 6. Views of Pascoe Vale Rd in the Strathmore Centre

2. Undertake a holistic urban design exercise, in collaboration with VicRoads, to explore additional opportunities to create a sense of destination, improve the amenity of the centre and facilitate crossing of Pascoe Vale Rd in the centre, as discussed above (priority high).
3. Maintain provision for on-street car parking on Pascoe Vale Rd (priority medium).

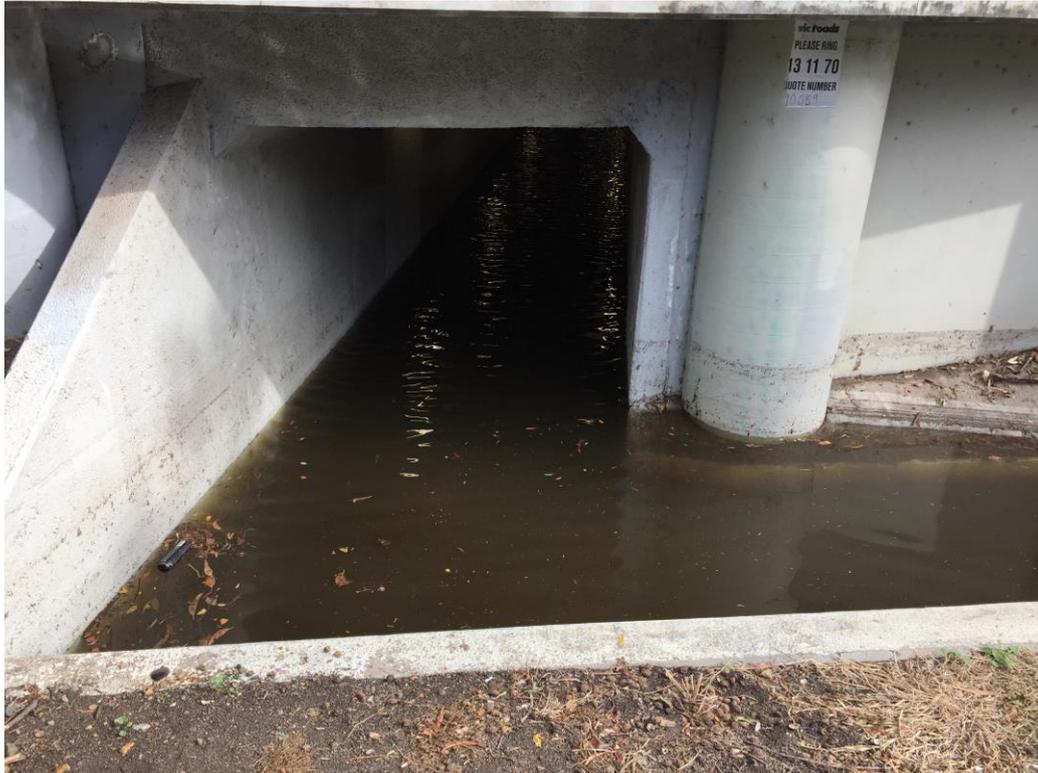
Figure 7. Deeply flooded pedestrian underpass beneath CityLink to access Wheeler St

Talbot Rd and Wheeler St was identified as a key potential route in PPN analysis, but we found that the underpass beneath CityLink was so heavily flooded that it was impossible to use. Discussions with a person on-site suggested this is usually the case. The apparent neglect of this issue would seem to reflect the typically low priority afforded to walking.
